# High-Strength Marine Metals

## Part 1 - Stainless Steel

### Why Stainless Steel is Not the Ideal Marine Metal

By Dave Gerr, CEng FRINA © Dave Gerr, 2009

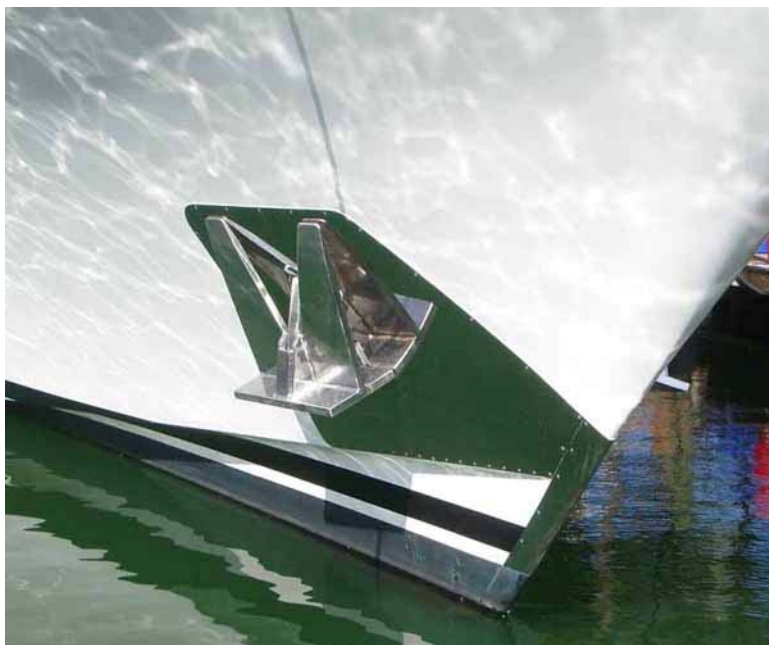
Stainless Anchor and Chafe Pads

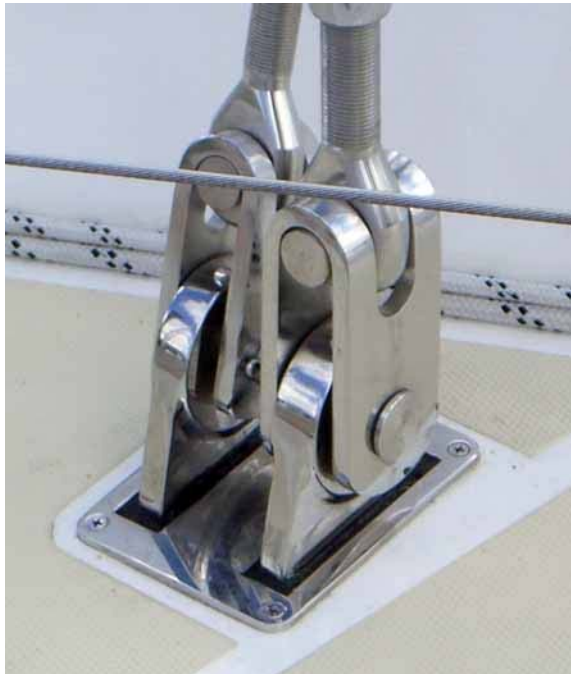
Stainless Chainplates, Toggles & Turnbuckles

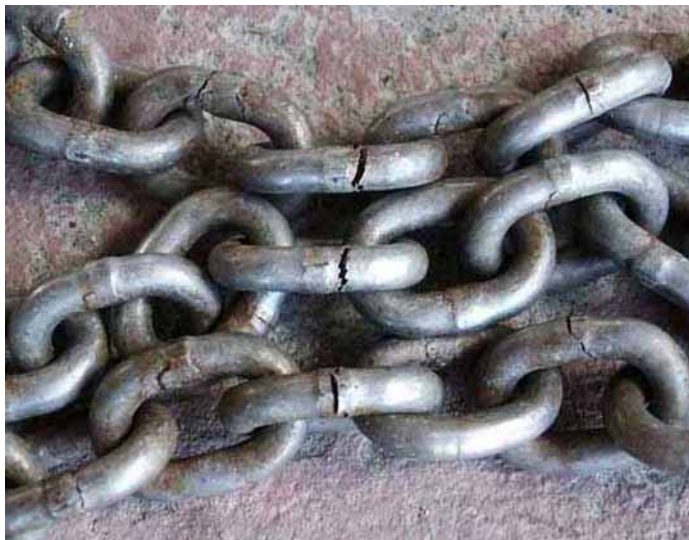
Stainless Anchor Chain Failure At Welds

welds are all too likely to suffer from pitting corrosion due to the internal chromium carbide formation. Such pitting corrosion has led to some truly spectacular failures.

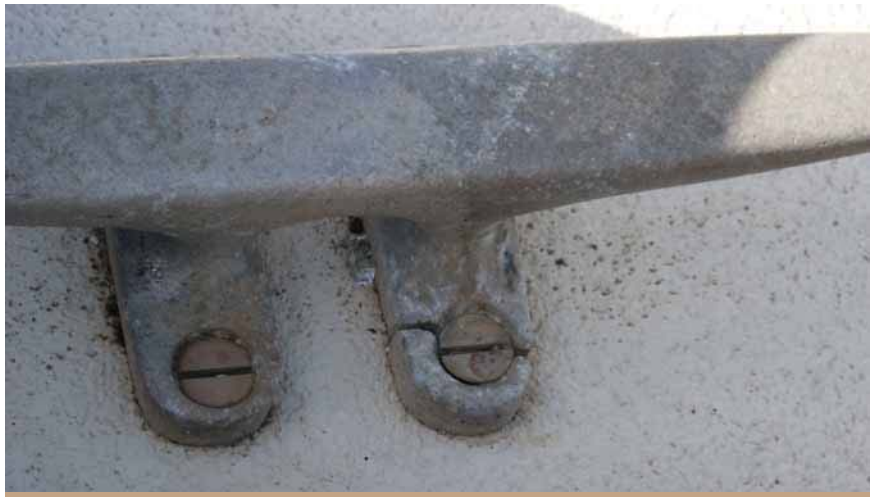
Stainless Steel Cleat Showing Corrosion Cracking
